WAUKESHA PUMP INSPECTION CHECKLIST

Customer:	Valued Customer
Model#	18-U1
Serial#	123456789
Cust PN:

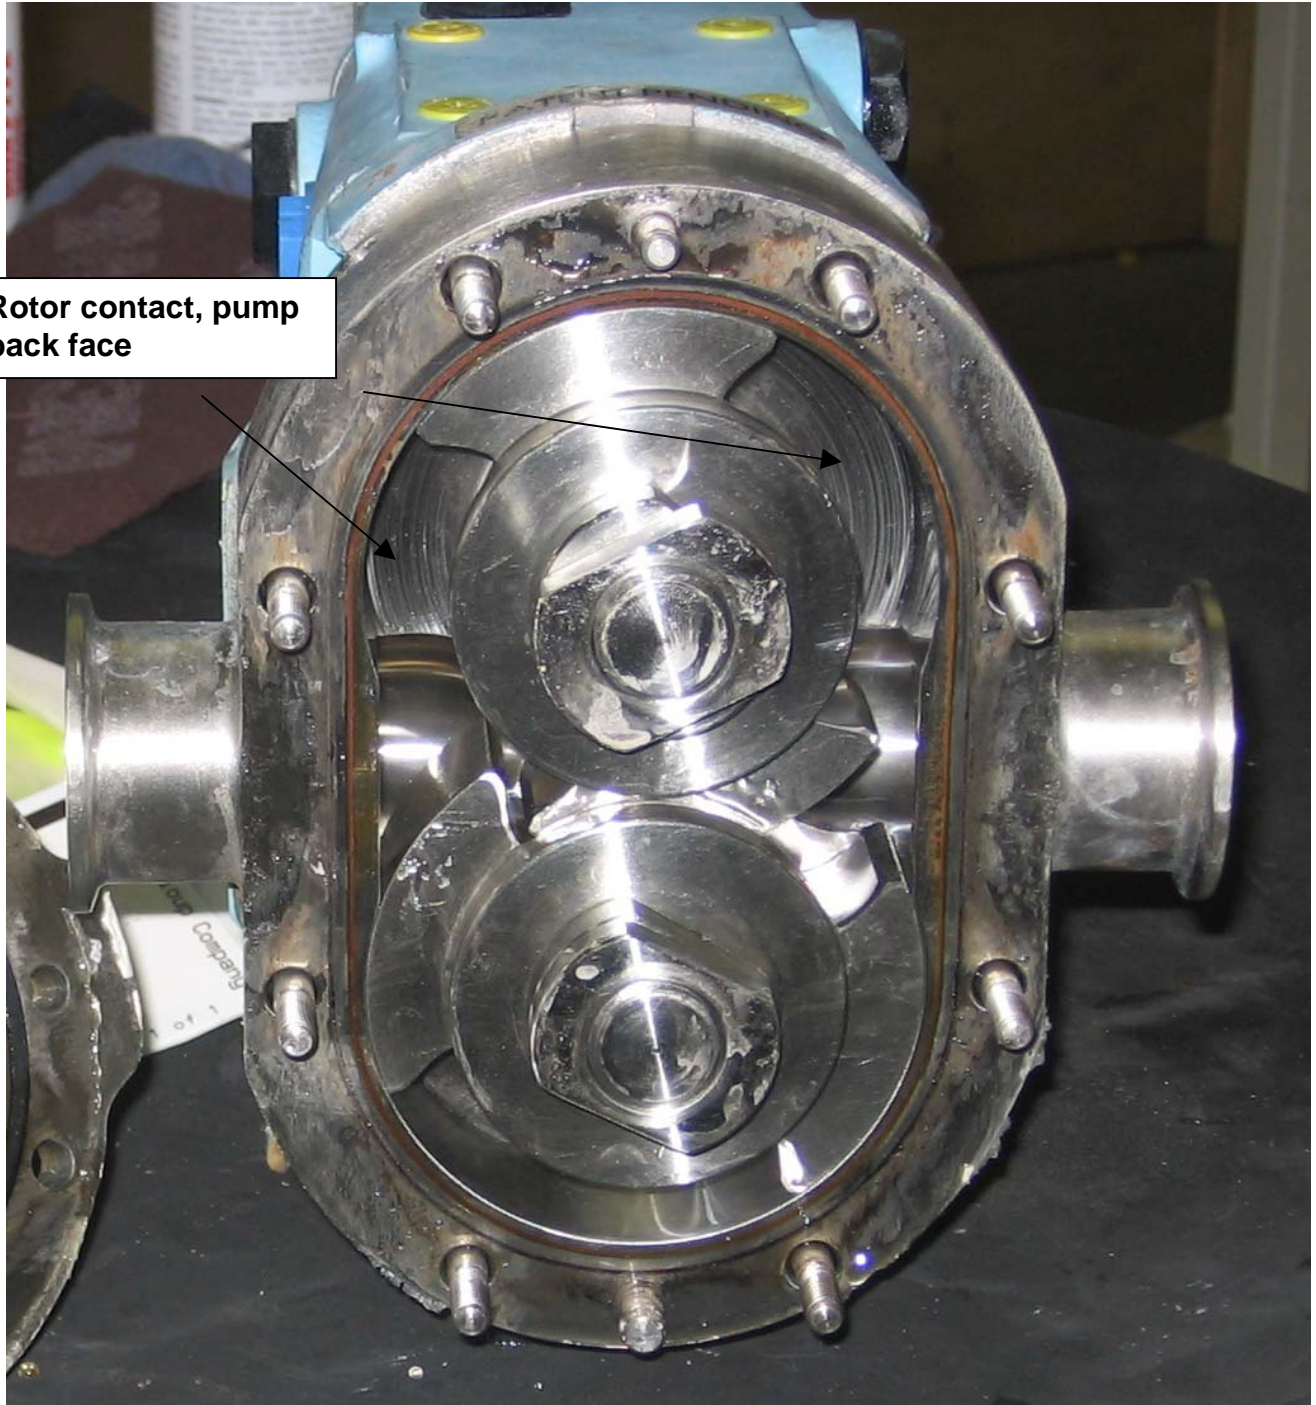
Describe Rotor Wear: Slight smearing on rotor wings due to contact with pump body back face

Describe Body Wear: Slight due to metal contact with drive shaft rotor

Upon receipt of this pump we observed a broken corner on the mounting shim. We also observed the pump is seized and will not operate. No cover wear visible on the inside cover. A check of tolerances showed the drive shaft (upper shaft) to be out of spec on both the front face and back face clearances. Removal of the rotors showed metal contact on the back face of the upper pump rotor area and on the rotor wings. Both contact areas are slight and can be cleaned up. A check of shaft deflection showed the bearing on the drive shaft was worn and was the cause of the metal contact.

Rotor contact, pump back face

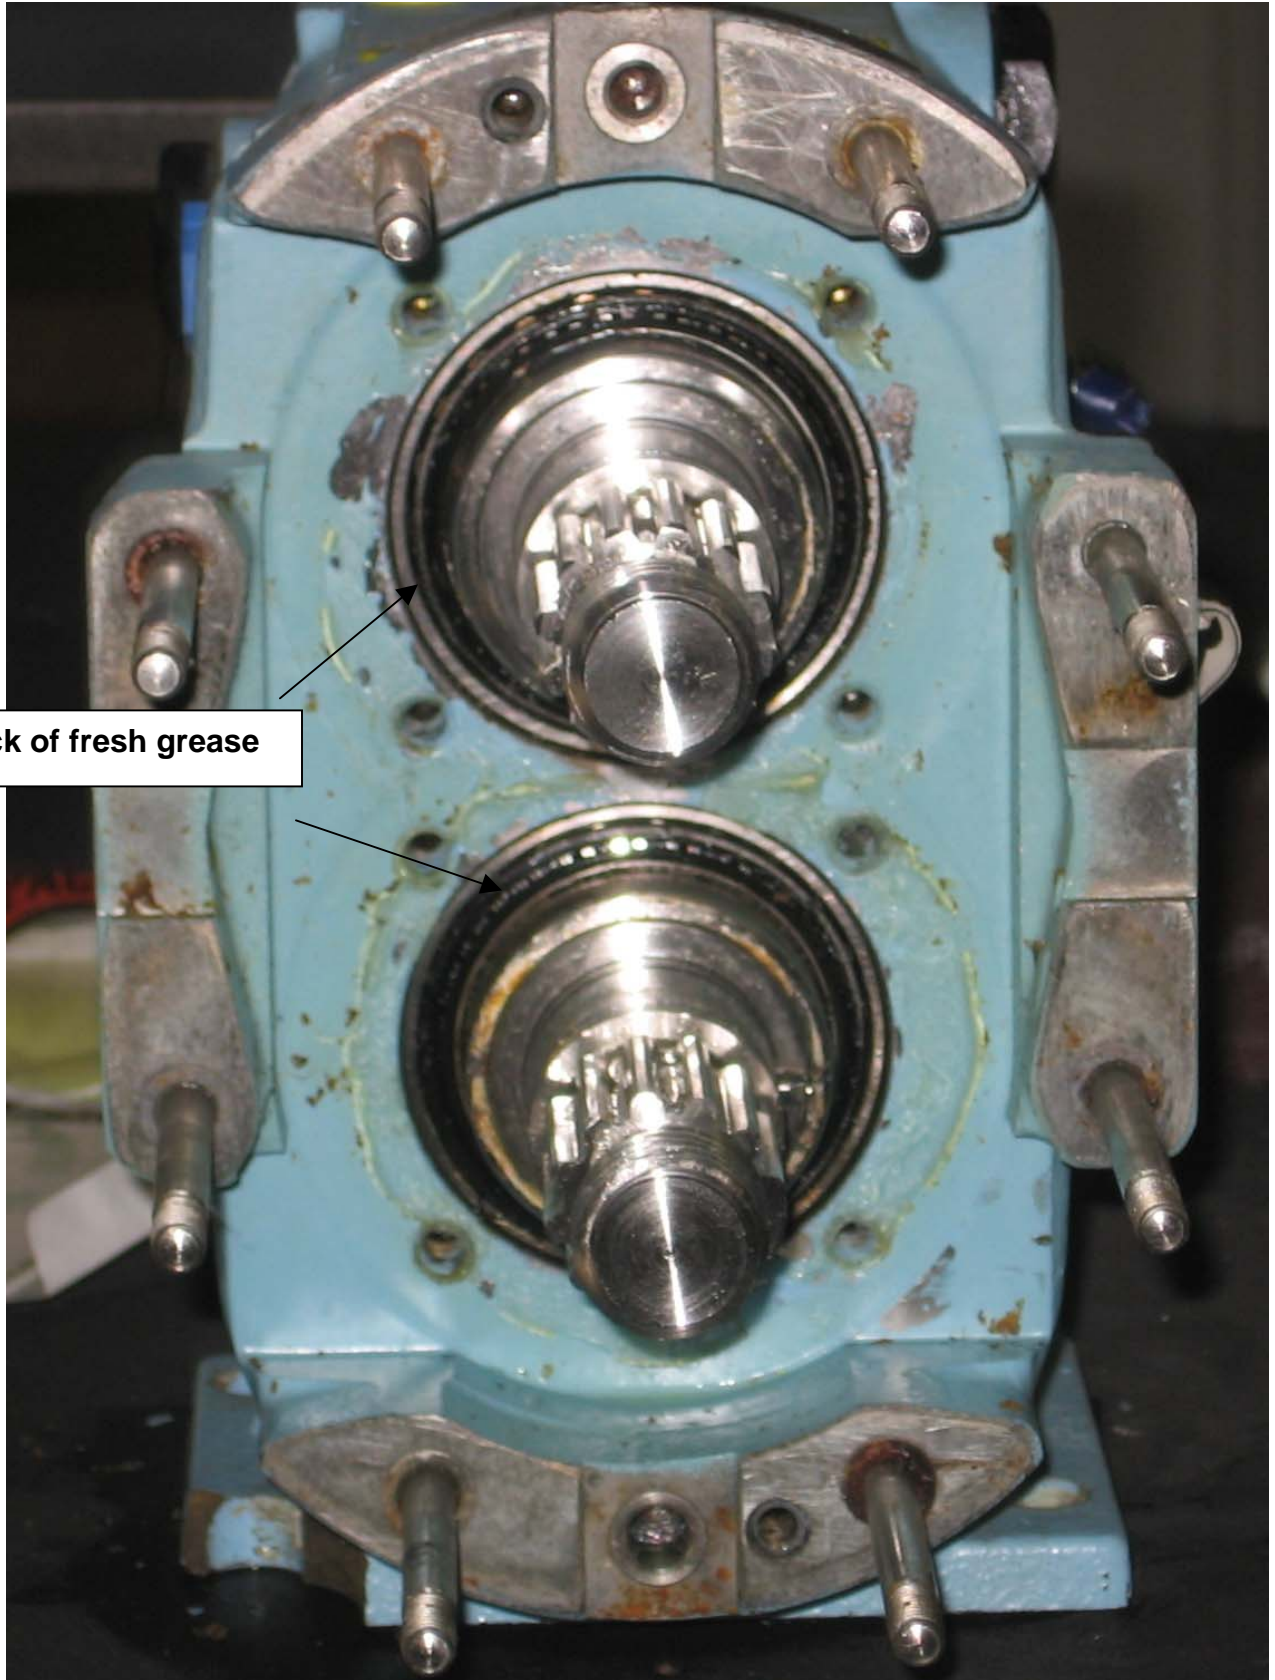
Describe Housing Cavity Contents: Little grease at rear bearing area

The failure of the bearing was the lack of grease. These pumps should be greased every 250 hours of operation. This pump appears to have the original grease applied during assembly. Had the pump been greased as recommended there would be grease in the center gear case, and there is none.

Lack of fresh grease
