WAUKESHA PUMP INSPECTION CHECKLIST

Customer:	Valued Customer
Model#	18-U1
Serial#	123456789
Cust PN:

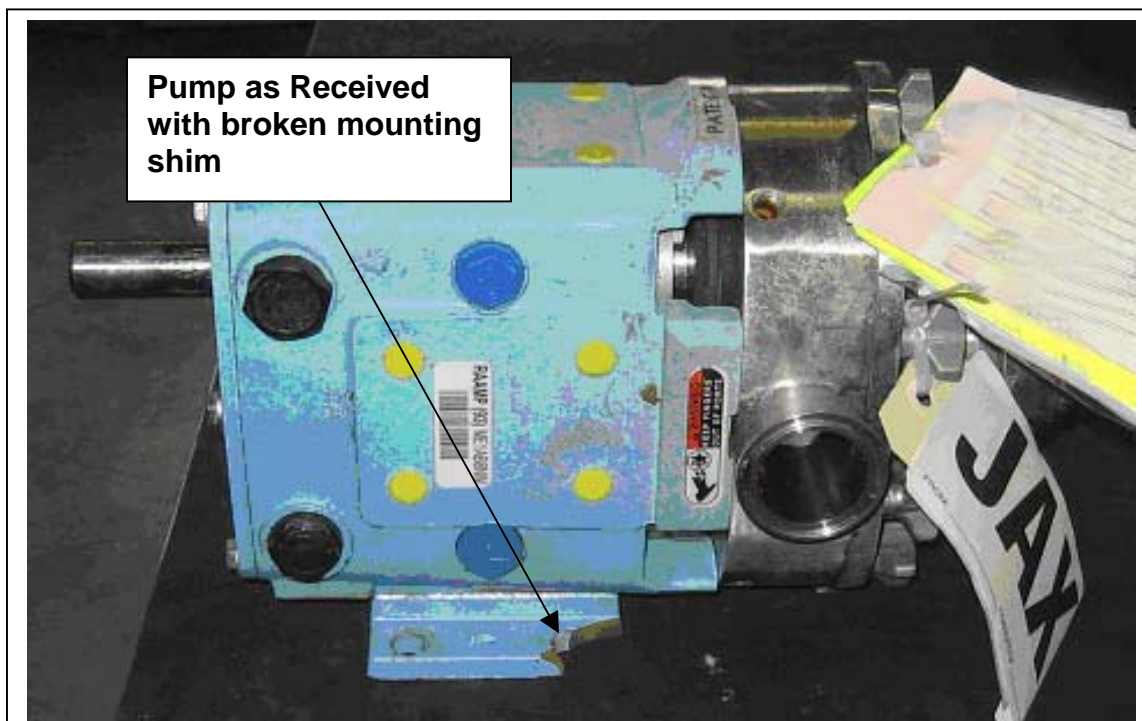
Describe Rotor Wear: Slight smearing on rotor wings due to contact with pump body back face

Describe Body Wear: Slight due to metal contact with drive shaft rotor

Upon receipt of this pump we observed a broken corner on the mounting shim. We also observed the pump is seized and will not operate. No cover wear visible on the inside cover. A check of tolerances showed the drive shaft (upper shaft) to be out of spec on both the front face and back face clearances. Removal of the rotors showed metal contact on the back face of the upper pump rotor area and on the rotor wings. Both contact areas are slight and can be cleaned up. A check of shaft deflection showed the bearing on the drive shaft was worn and was the cause of the metal contact.

The failure of the bearing was the lack of grease. These pumps should be greased every 250 hours of operation. This pump appears to have the original grease applied during assembly. Had the pump been greased as recommended there would be grease in the center gear case, and there is none.
